Reeder Home Inspections LLC

Inspection Report

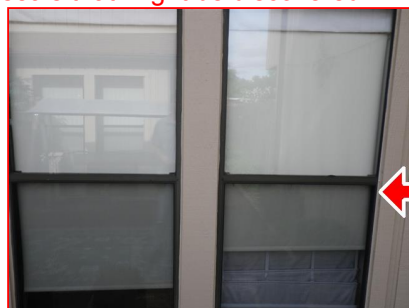
2.0 Item 1(Picture)

(2) Condensation and/or cloudiness visible in the noted windows (master window and dining room), indicate broken thermal seals. Glass replacement is necessary to restore original efficiency and cosmetic condition. If you have broken seals replaced at this time, have the contractor check all windows again and replace any additional broken seals that might be discovered.

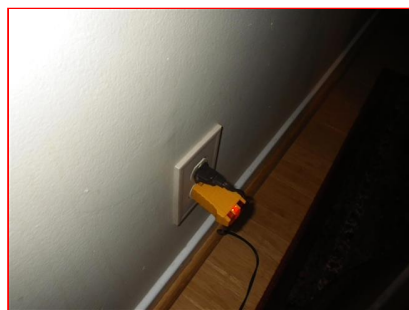
4.3 Item 1(Picture)

(2) Correct the three prong outlet(s) identified at various areas as having an "open ground". This creates the appearance of a grounded outlet without providing the safety of a ground wire.

(2) *Correct the three prong outlet(s) identified at various areas as having an "open ground". This creates the appearance of a grounded outlet without providing the safety of a ground wire.*

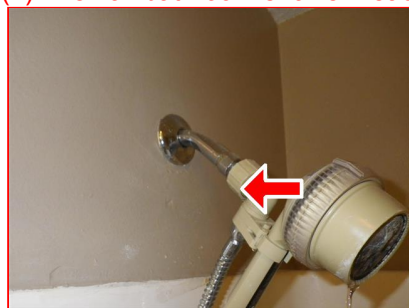
8.1 Item 1(Picture)

(2) The hall bathroom shower head leaks and will need replacement.

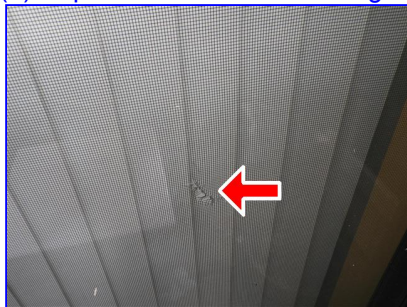
2.0 Item 2(Picture)

(3) Repair as needed the damaged screens.

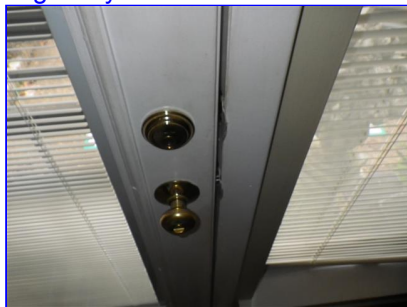
2.1 Item 1(Picture)

(2) Some municipalities consider double-keyed deadbolt locks at entrance doors a fire safety hazard and require single keyed locks instead. At a minimum keep the key by the door(s).

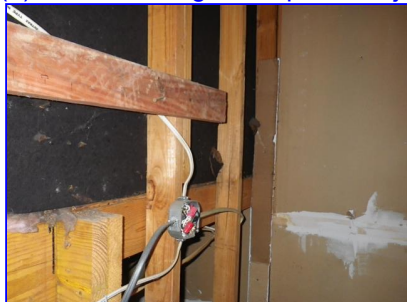
4.2 Item 1(Picture)

(2) Install missing cover plates at junction boxes to contain splices properly at the attic.

(2) *Install missing cover plates at junction boxes to contain splices properly at the attic.*

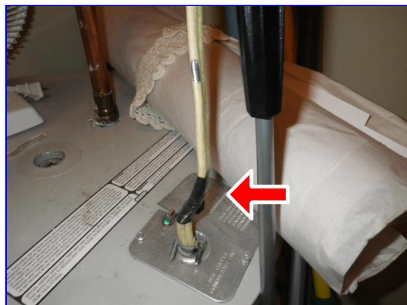
4.2 Item 2(Picture)

(3) The water heater wiring had electrical tape installed at the top of the water heater. This could be where a splice was made or where the wire sheathing was damaged. Be aware of this and correct as needed.

(3) *The water heater wiring had electrical tape installed at the top of the water heater. This could be where a splice was made or where the wire sheathing was damaged. Be aware of this and correct as needed.*

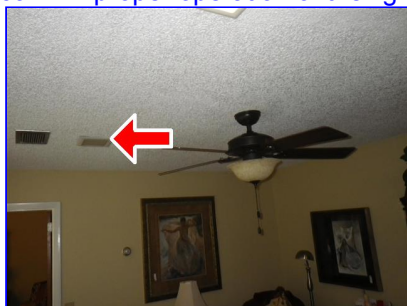
4.5 Item 1(Picture)

(2) A few lights did not respond, such as the living room. You might wish to ask the seller to replace the bulbs and confirm proper operation of the lights during your pre-closing walk-through.

(2) *A few lights did not respond, such as the living room. You might wish to ask the seller to replace the bulbs and confirm proper operation of the lights during your pre-closing walk-through.*

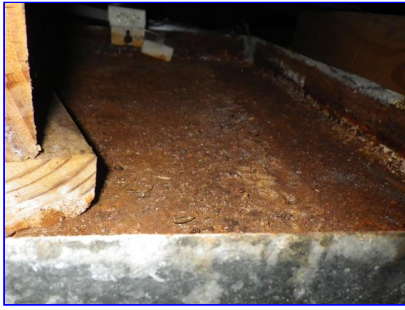
5.0 Item 2(Picture)

(2) The furnace pan was rusty but no leaks were noted. Monitor and correct as needed.

(2) *The furnace pan was rusty but no leaks were noted. Monitor and correct as needed.*

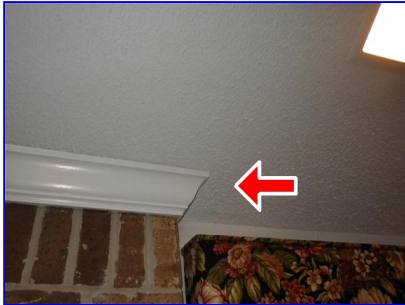
6.0 Item 1(Picture)

(2) Monitor the ceiling near the fireplace as light stains were noted at the ceiling.

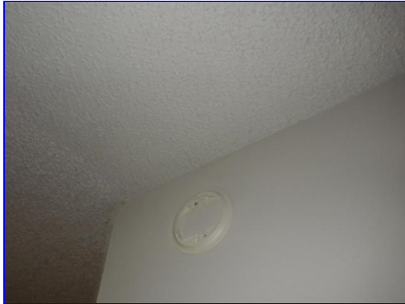
6.0 Item 2(Picture)

(3) Some of the smoke detectors were missing. Correct as needed.

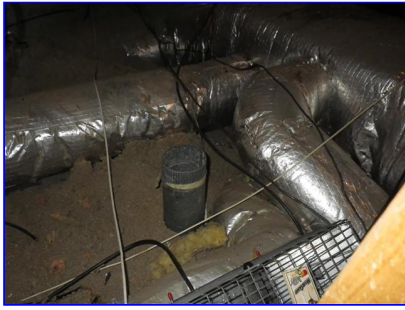
7.0 Item 1(Picture)

(2) The stove exhaust fan vents into the attic while it should vent to the exterior of the home. Correct as needed.

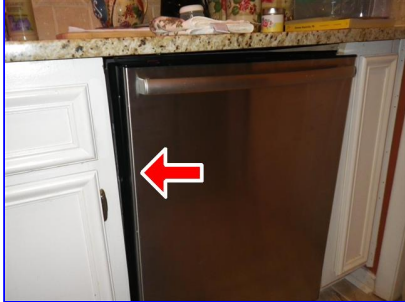
7.0 Item 2(Picture)

(3) Secure the loose dishwasher.

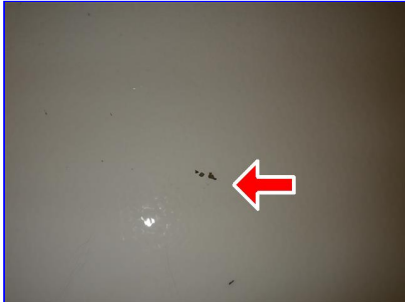
8.0 Item 1(Picture)

(2) Repair as needed the damaged fiberglass tub (chipped) at the hall bathroom.
